WT-101

(6) DAMAGE TO EXISTING EPG STRUCTURES (U)

This report presents the final results of one of the projects participating in the military-effects programs of Operation Hardtack. Overall information about this and the other military-effects projects can be obtained from ITR-1660, the "Summary Report of the Commander, Task Unit 3." This technical summary includes: (1) tables listing each detonation with its yield, type, environment, meteorological conditions, etc.; (2) maps showing shot locations; (3) discussion of results by programs; (4) summaries of objectives, procedures, results, etc., for all projects; and (5) a listing of project reports for the military-effects programs.

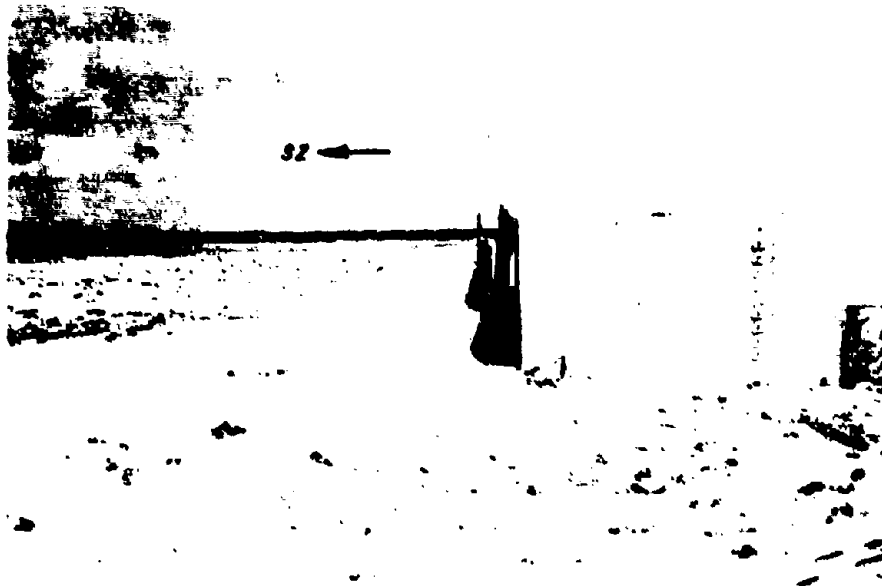
air blast on the immediate area. The telephone pole adjacent to the structure was broken at the roof line. Although the door of this structure could not be sealed tightly due to faulty seating, it is assumed that the pressure build-up within the station was slight. Three one-hundred-watt light bulbs fastened to the ceiling did not break, indicating that the pressure within the station was very low. Three inches of mud covered the floor and high water mark was noted 1 foot 8 inches above the floor. The sand bags were strewn about the entire area, the top of the berm was lowered 2 feet, and the earth mound in front of the station was reduced 7 feet in height. Indications were that at least 3 feet of water had been confined within the circular berm area. Pre-Fir, post-Fir, and post-Sycamore profiles of the island between Stations 560.01 and 1519 are shown in Figure 3.10.

Figure 3.8 Post-Fir, (Item 2) Station 560.01. Pressure level: Fir, 30 psi.

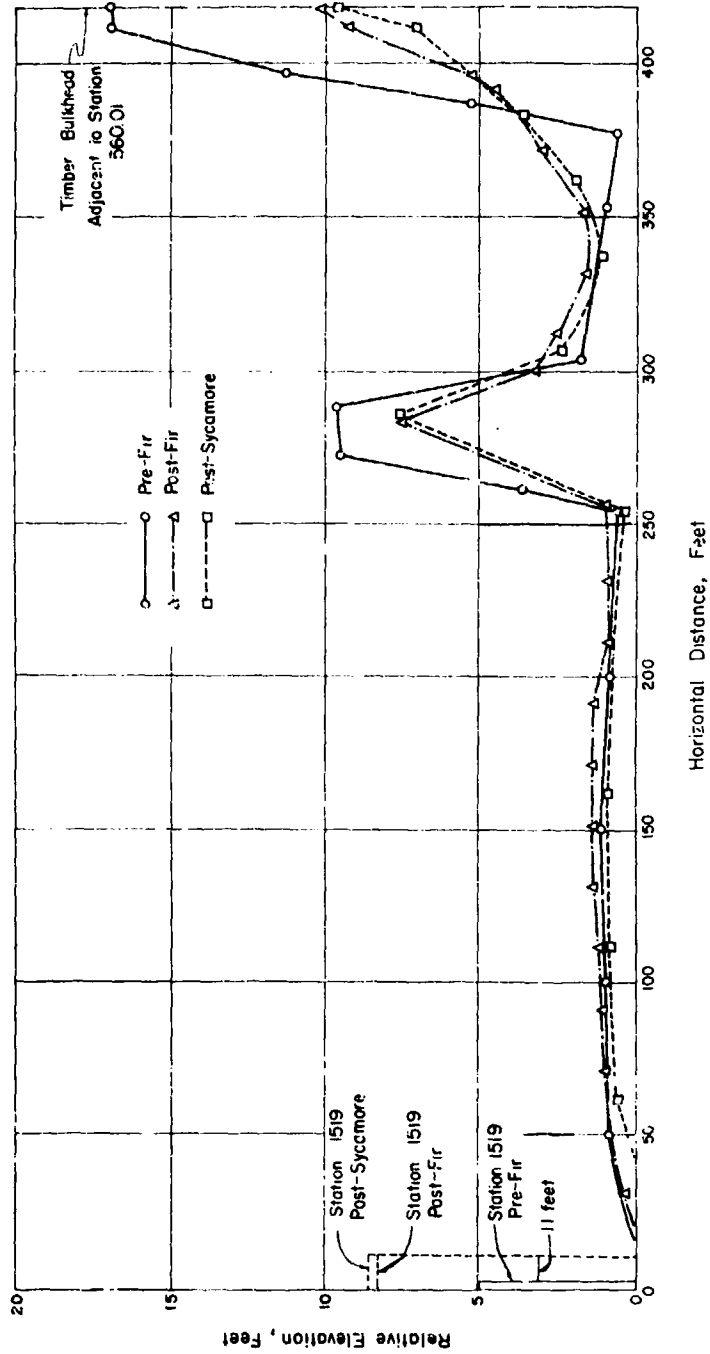
evident from Figure 3.10 that Shot Sycamore caused very little, if any, additional erosion.

Figure 3.10 Ground-surface profile between (Item 2) Station 560.01 and (Item 4) Station 1519.

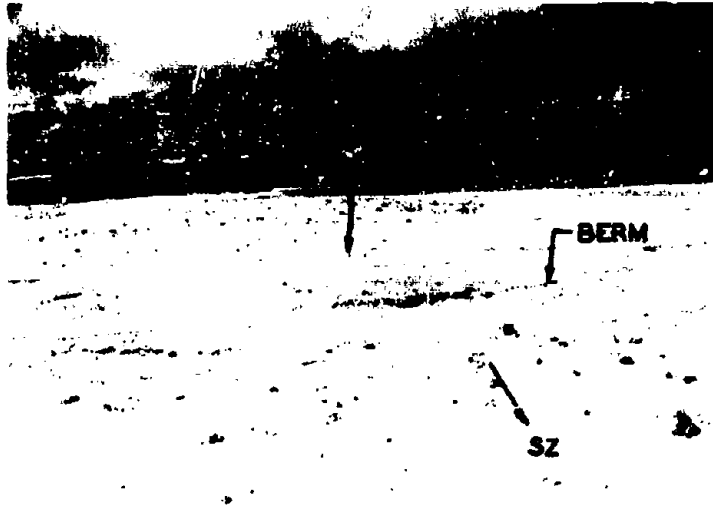
The structure was completely destroyed from the effects of Shot Poplar. Figure 3.11 shows there was hardly a trace that the structure once existed and only a slight trace indicating the location of the circular earth berm that once surrounded the structure.

Figure 3.11 Post-Poplar, (Item 2) Station 560.01, complete destruction of station. Station 1341 can be seen in background. Pressure level: Poplar, 1,200 psi.

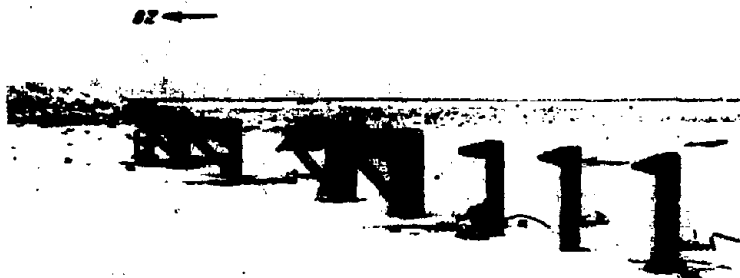
These stations received an estimated air pressure of 30, 6, 12, 10, and 1,200 psi from Shots Fir, Sycamore, Aspen, Cedar, and Poplar, respectively. The stations were undamaged from the first four shots except for slight erosion of the soil around the concrete foundations, (Figure 3.12); however, the force from Shot Poplar destroyed the steel drag members, leaving only the concrete bases (Figure 3.13).

Figure 3.12 Post-Fir, (Item 3) Stations 152.01 and 153.01. Pressure level: Fir, 30 psi.

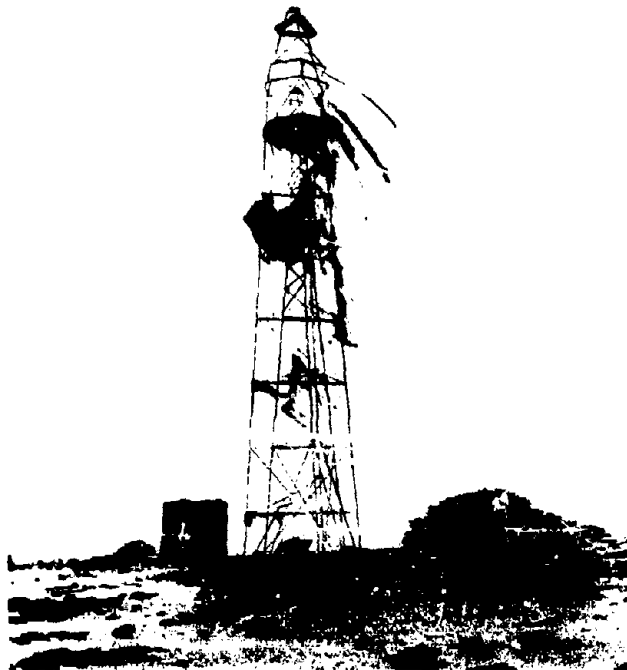
The air blast and water wave from Shot Fir swept nearly all vegetation from the island. Inundation caused from Shot Fir extended past Station 78.01 as can be seen in Figure 3.16. A light steel tower, shown in Figure 3.17, was located in the 25-psi air-overpressure range of Shot Fir and was completely destroyed, leaving no trace of the structure.

Figure 3.17 Preshot, steel tower on Site Charlie; completely destroyed by Shot Fir, 25 psi.

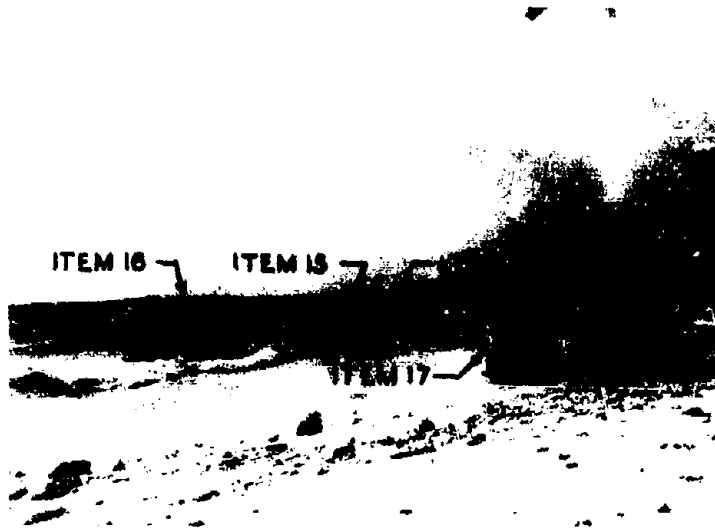
This station was located in the estimated 490-, 260-, and 1,400-psi overpressure range for Shots Nutmeg, Hickory, and Juniper, respectively. Even though the station was exposed to extremely high overpressures it was not damaged structurally. A post-Juniper view of this structure is shown in Figure 3.36.

Figure 3.36 Post-Juniper view of east end of Site Tare looking toward surface zero.

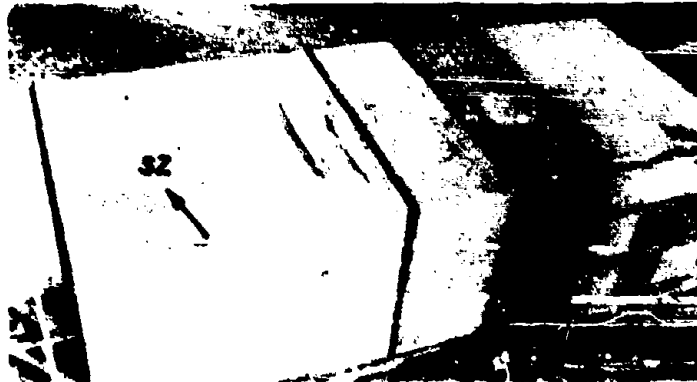
The structure responded appreciably to the effects of Shot Walnut (pressure level of 16 psi). Figures 4.40 and 4.41 show the overall damage, which can be compared with Figure 4.39 for pre-Walnut damage. The corrugated siding on the metal buildings was damaged severely. Major damage was observed in Building 5; damage to the front face and first-floor columns is shown in

Figure 4.41 Post-Walnut, (Item 26) Station 3.1.1, aerial view. Pressure level: Walnut, 16 psi.

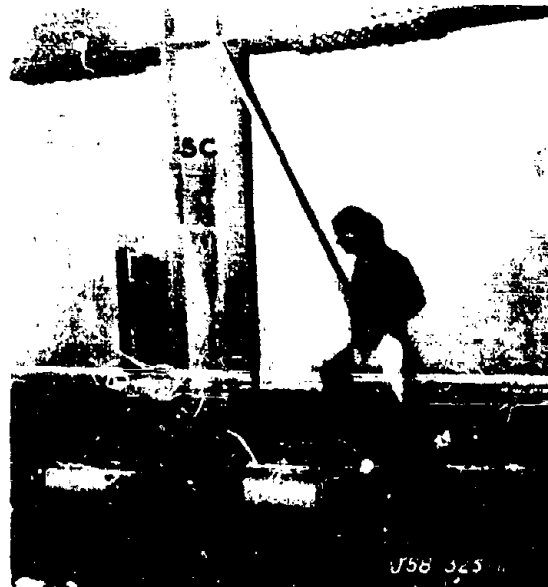
Figure 4.49; this picture also shows the suspended plumb bob that was used in measuring column offsets. The roof in Building 6 lifted upward 3 to 4 inches, tapering to its normal position at a point 7 or 8 feet from the front wall (Figure 4.50). The cracked roof section in Building 4 opened considerably, being displaced a maximum of 10 inches at the center of the section adjacent to Column Line 10 and the north end of the building (Figures 4.51 and 4.52). The bottom bars (No. 4) of the slab failed in tension as was noted by the neck-down of the bars at the point of breakage.

Figure 4.49 Post-Walnut, (Item 26) Station 3.1.1, Column 5C, first floor of Building 2. Pressure level: Walnut, 16 psi.

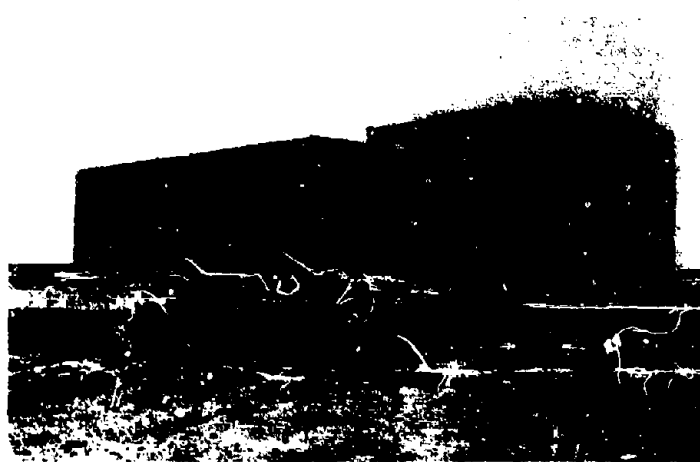
Shot Elder (pressure level of 20 psi) caused additional damage as can be compared by viewing Figures 4.53 and 4.54 with Figure 4.40. The shear resistance of the first-floor columns of Building 5, the concrete frame, drag structure, was overcome and the upper floors intact settled down with the second floor girders resting on the collapsed first floor columns (Figure 4.55). The column offset measurements for Buildings 2, 3, and 6 are shown in Table 4.5. A front view of Buildings 1, 2, and 3 is shown in Figure 4.56. Building 3, the reinforced-concrete (diffraction) structure underwent additional permanent lateral movement, but unlike its counterpart, Building 5 (drag-type structure), the columns on each floor displaced laterally approximately the same amount and showed signs of damage (Figures 4.57, 4.58, and 4.59). The rear wall of Building 3 cracked horizontally, evidently from bending (Figure 4.60). Buildings 2 and 6 deflected approximately $\frac{1}{2}$ inch away from surface zero. However, most of the roof section of Building 6 was blown upward by the blast and thrown to the ground surface to the rear of the structure (Figure 4.61). Channel shear keys welded to the roof girder are also visible in the picture as well as the damage to the roof at the south end of Building 4. The major damage to Building 4 occurred at the north end where the roof was punched inward and is supported by the cantilever effect of the reinforcing steel (Figures 4.62, 4.63, and 4.64).

Figure 4.53 Post-Elder, (Item 26) Station 3.1.1, front view. Pressure level: Elder, 20 psi.

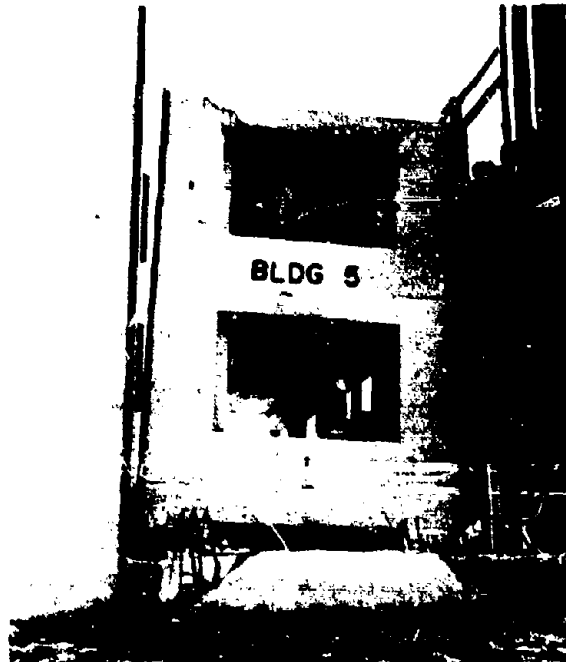
Figure 4.55 Post-Elder, (Item 26) Station 3.1.1, close-up of Building 5, first floor collapsed. Pressure level: Elder, 20 psi.

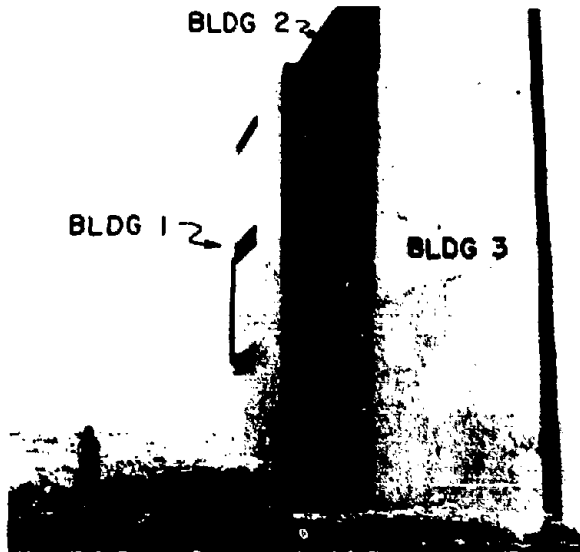
Figure 4.56 Post-Elder, (Item 26) Station 3.1.1, close-up of Buildings 1, 2, and 3. Pressure level: Elder 20 psi.

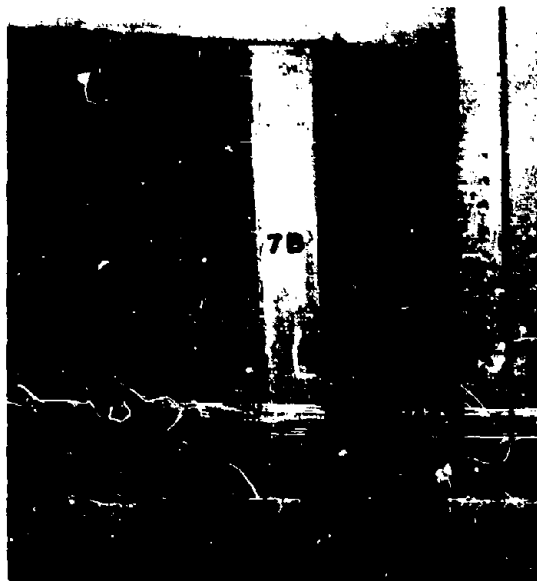
Figure 4.59 Post-Elder, (Item 26) Station 3.1.1,
Columns 7 and 8B, third floor of Building 3.
Pressure level: Elder, 20 psi.

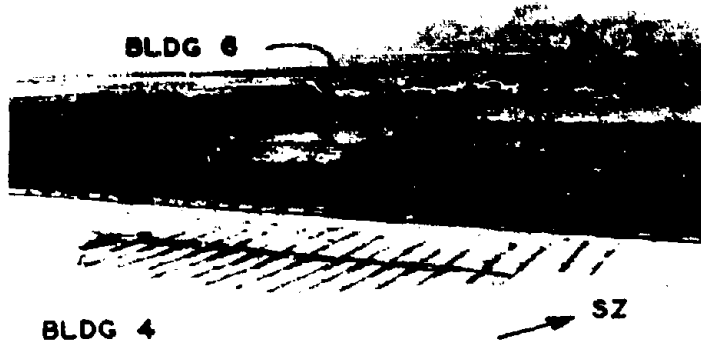
Figure 4.61 Post-Elder, (Item 26) Station 3.1.1, destroyed roof section of Building 6 and damaged area to roof at south end of Building 4. Pressure level: Elder, 20 psi.

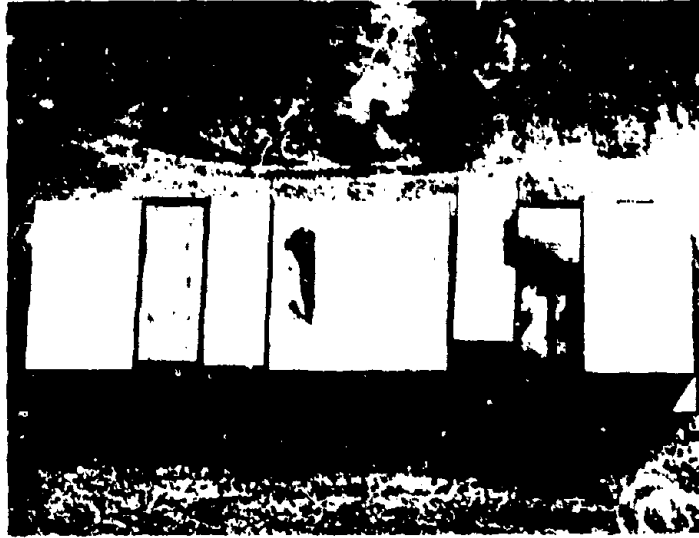
The station was next investigated after Shots Dogwood, Olive, and Pine had been fired; the resulting estimated overpressure levels were 12, 8.4, and 13 psi, respectively. An overall postoperation view of the structure is shown in Figure 4.65. Little additional damage was observed for Buildings 2, 3, or 6. As shown in Table 4.5, the postoperation column displacements for Building 6 were approximately the same as those for post-Elder; the postoperation displacements for Buildings 2 and 3 were less than those for post-Elder, indicating that rebound for the buildings occurred at a slow rate.

Figure 4.65 Post-Dogwood Olive, and -Pine, (Item 26) Station 3.1.1, aerial view. Pressure levels: Dogwood, 12 psi; Olive, 8.4 psi; and Pine, 13 psi.

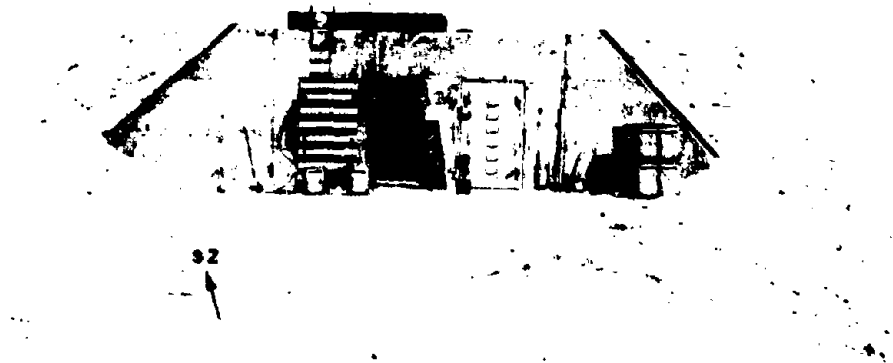
sure of 17 psi from Shot Elder. The antenna and ventilating devices on top of this station (Figure 4.72) were removed prior to Shot Elder.

Figure 4.72 Postshot, (Item 29) Station 77.02, recording station. Pressure level: Elder, 17 psi.

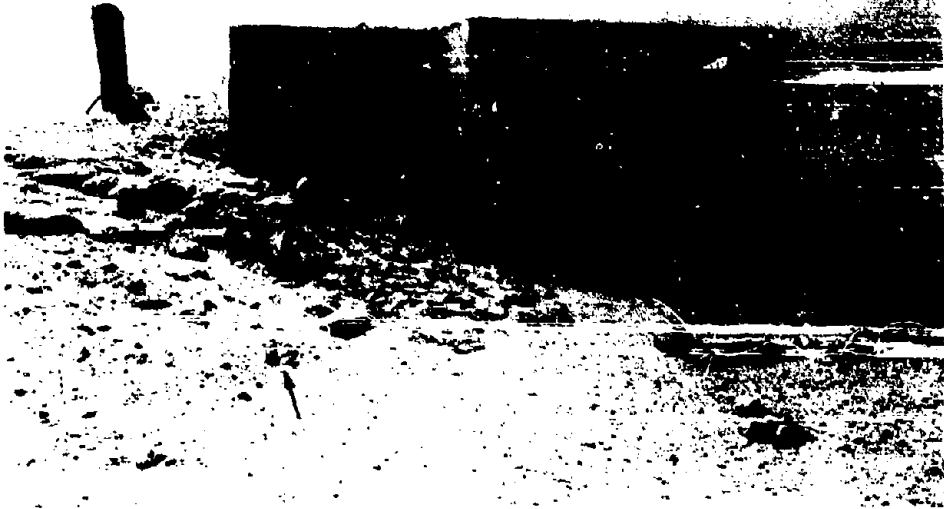
The structure was located in the 450-psi air-overpressure range for Shot Cactus and damaged only from that shot. The damage was confined to the side tunnel. A preshot view of the entrance (side away from ground zero) is shown in Figure 4.79 and a post-Cactus view is shown in Figure 4.80. Thermal radiation estimated to be 20 cal/cm² from Shot Butternut, which was fired after Shot Cactus, burned the black paint off the wall surface as can be seen by comparing Figures 4.79 and 4.80. A preshot view of the entrance to the side tunnel is shown in Figure 4.81. A post-Cactus view, Figure 4.82, shows the damaged entranceway. Apparently the blast wave that entered the tunnel-like entrance (side-on to the shock front) was reflected at the tunnel's end. The resulting increase in pressure caused the tunnel walls and roof to separate and crack as though an explosion had occurred inside the tunnel. An interior crack near the junction with main structure showing the "bulging" failure can be seen in Figure 4.83. The tunnel was not fastened with dowels to the main station but merely keyed.

Figure 4.80 Postshot, (Item 31) Station 1130, entrance.
Pressure level: Cactus, 450 psi; Eutternut, 20 cal/cm².

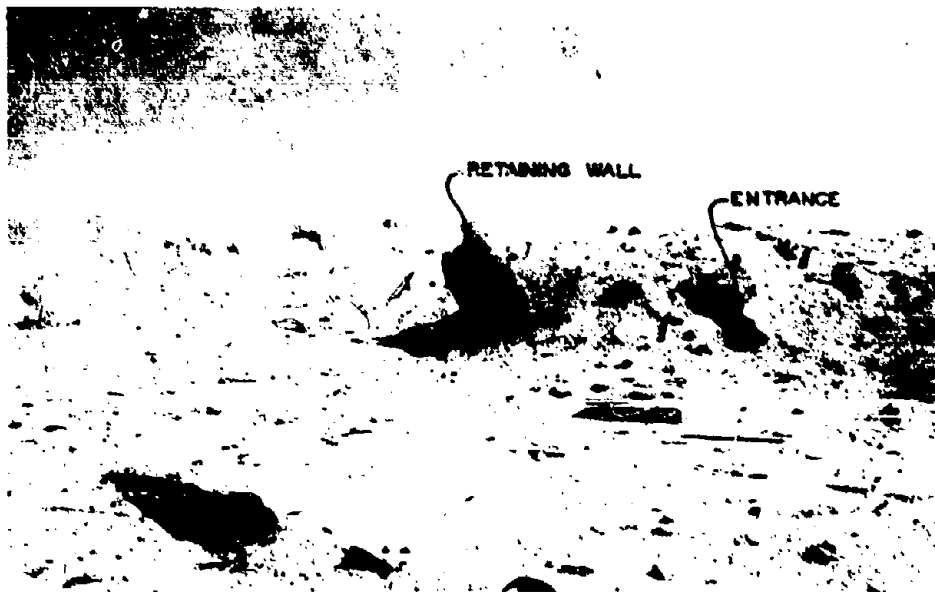
Figure 4.89 Post-Cactus, (Item 34) Station 1612, retaining wall and entrance to station. Pressure level: Cactus, 1,600 psi.

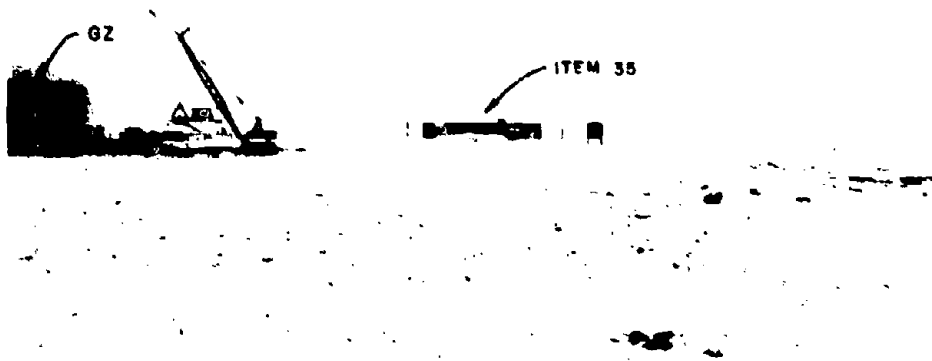
Figure 4.91 Preshot, (Item 35) Stations 1523.01 to 1523.04, Site Yvonne.

4.3.5 Item 35, Stations 1523.01 to 1523.04. Four steel-pipe towers encased by a plywood covering were constructed for Operation Hardtack (1958). A corrugated-metal pipe (48 inches in diameter) mounded with sand led from each station to ground zero. A preshot picture of this station is shown as Figure 4.91.

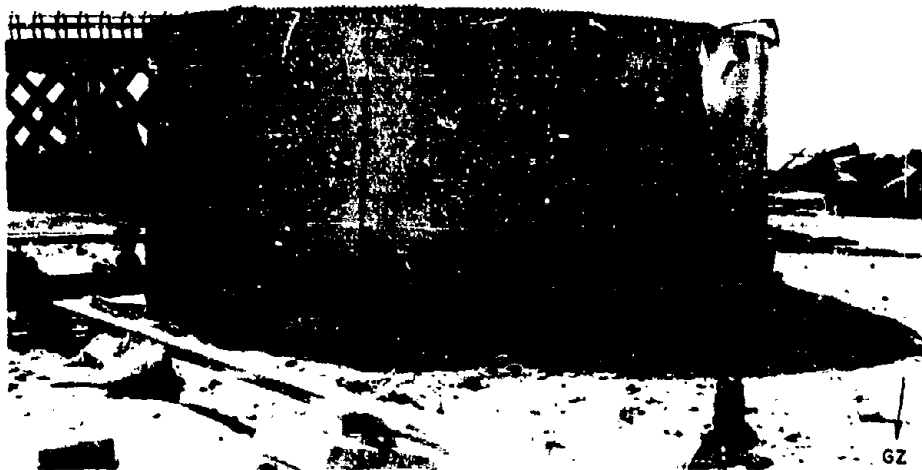
The tank was located in the 1.5-, 6.5-, 2.4-, 7.0-, 2.5-, 3.4-, 2.3-, and 3.4-psi air-overpressure zones for Shots Cactus, Butternut, Holly, Magnolia, Rose, Linden, Sequoia, and Pisonia. The tank was not affected by Shot Cactus but was damaged by Shot Butternut as shown in Figure 4.96. The tank was half full of water at that time. Shot Holly had no additional effects. The tank was damaged additionally by Shot Magnolia as seen by the local buckling failure around the top perimeter and the dishing of the roof as shown in Figure 4.97. No additional damage from the remain-

Figure 4.96 Post-Butternut, (Item 37) 21,000-gallon water tank.
Pressure level: Butternut, 6.5 psi.

ing shots was observed. Even though the tank was badly dented near the upper rim none of the bolts or bolt holes showed signs of incipient failure, and it appeared that the tank with some minor repairs could easily be placed in use again. The above-ground connections of 4-inch and 2-inch water pipes and the exposed 4-inch, rising-stem, gate valves (125-psi rated) were undamaged.

A 21,000-gallon water tank (Item 37) directly exposed to 6.5 and 7.0 psi of air overpressures received light damage. The roof was dished in, and there was a small amount of buckling of the sides above the level of liquid in the tank. In addition, it was noted that there was no damage to the exterior connecting piping.

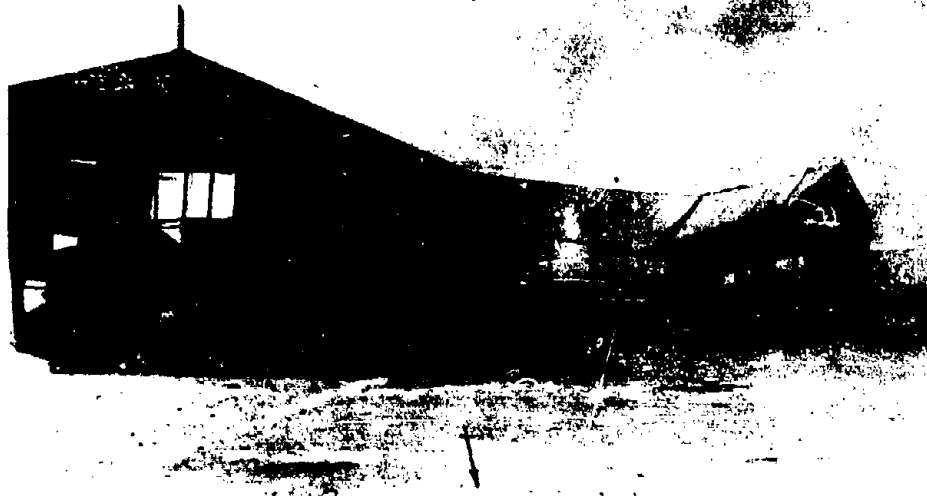
Timber Buildings and Tents. Light temporary timber buildings were severely damaged from the 1.5- to 2.0-psi air overpressure from Shot Cactus. The first two rows of

tents (closest to ground zero) were not only collapsed but moved away from ground zero a distance of 6 to 8 feet (Figure 4.98). The remaining tents did not experience this movement but were partially collapsed. The light-plywood-covered buildings were severely damaged, the smaller buildings being damaged the least. The frames of many structures were collapsed to varying degrees and the plywood siding of many was blown off (Figure 4.99). The latrine which was the closest camp building to ground zero was not only damaged but moved 6 inches away from ground zero. The blast that entered this building apparently exerted a greater pressure than the external pressure, as indicated by the outward bulging of the roof and side walls as shown in Figure 4.100. None of the buildings or tents were charred from the thermal pulse from Shot Cactus. The estimated pressure level of 5.8 to 8.2 psi from Shot Butternut completely destroyed all the tents and timber buildings.

Figure 4.99 Post-Cactus, camp damage, light timber construction.
Pressure level: Cactus, 1.5 psi.

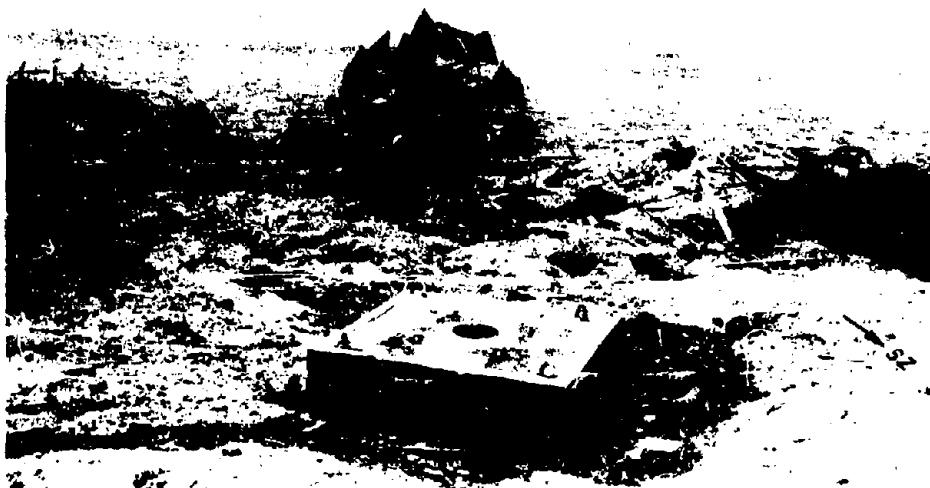
Figure 4.102 Post-Butternut, radar reflector. Pressure level: Butternut, 5.8 psi.

Radar Reflector. A multiunit, radar reflector, undamaged from the effects of Shot Cactus, was ripped from its concrete foundation and thrown 50 feet from the effects of Shot Butternut. A view of this station, which was located in the estimated 5.8-psi range from Shot Butternut, is shown in Figure 4.102.

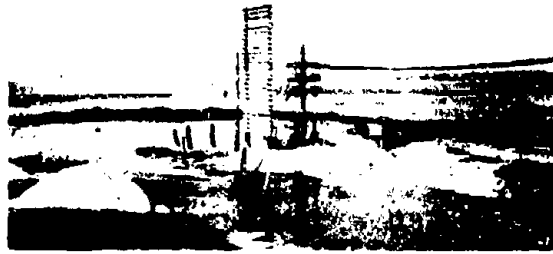
Figure D.5 Transformer station after wave action ceased and water subsided. Shot Oak, Site Elmer.
